Rectifying a stiff Rudder on a Najad 360

Submitted by Simon James

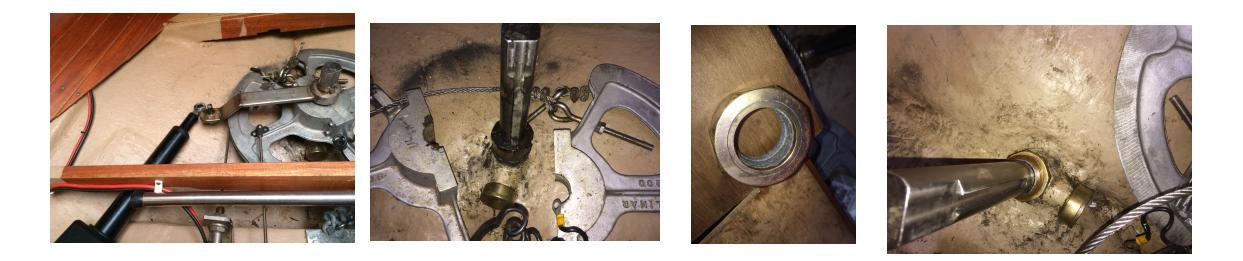
Once the steering cables have been disconnected (record the length of the cable adjustment bolts) and the quadrant has been removed, it will exposes the seal which is made up of compressed packing glands in the cap. Next unscrew the top seal cap which is locked in place with a nut below it. These are large nuts but lightly loaded which

will require large spanners. I made up a pair of aluminium spanners to suit which may be worth doing so that the seal can be adjusted when reassembled and during initial trials. Now carefully slide the cap upwards off the now exposed rudder pintle. It is important to ensure the pintle shaft is not scored or damaged in the vicinity of the seal.

Remove the 2 packing gland rings from the top seal cap, care is needed to not damage the inside surface of the cap in the region of where the seal fits, clean the area of dirty grease and clean the greasing cap on the side of the upper bearing housing.

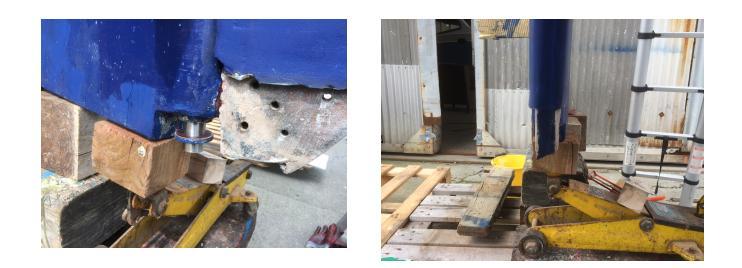
Moving outside, start by blocking up the underside of the rudder to support it as the lower bearing is dismantled. I used several wooden pallets and a hydraulic car jack to control it as it was lowered. When planning the blocking arrangement allow for sufficient space to drop the rudder and clear the top portion of the rudder pintle by about 15 inches.

Once the support has been arranged remove the bottom bearing brass shoe. Remove the M8 counter sunk machine screws then gently part the sealant that will have been used to hold the shoe In place. Remember the shoe is a cast brass fitting on a fibreglass skeg which does not want to be hit heavily with a hammer. In theory the lower shoe takes all the weight of the rudder so as the shoe is dismantled the rudder needs supporting, in practice if the rudder is very stiff it will stay in place and will require a considerable amount of waggling to to drop the rudder.

As the rudder top pintle comes free the rudder needs to be supported and lowered. I managed to do it on my own but would have been better to have had additional help at this point.
